Lessons from Hagibis:

Learning to Cope with Intensifying Disasters
in the Age of New Normal

February 2020

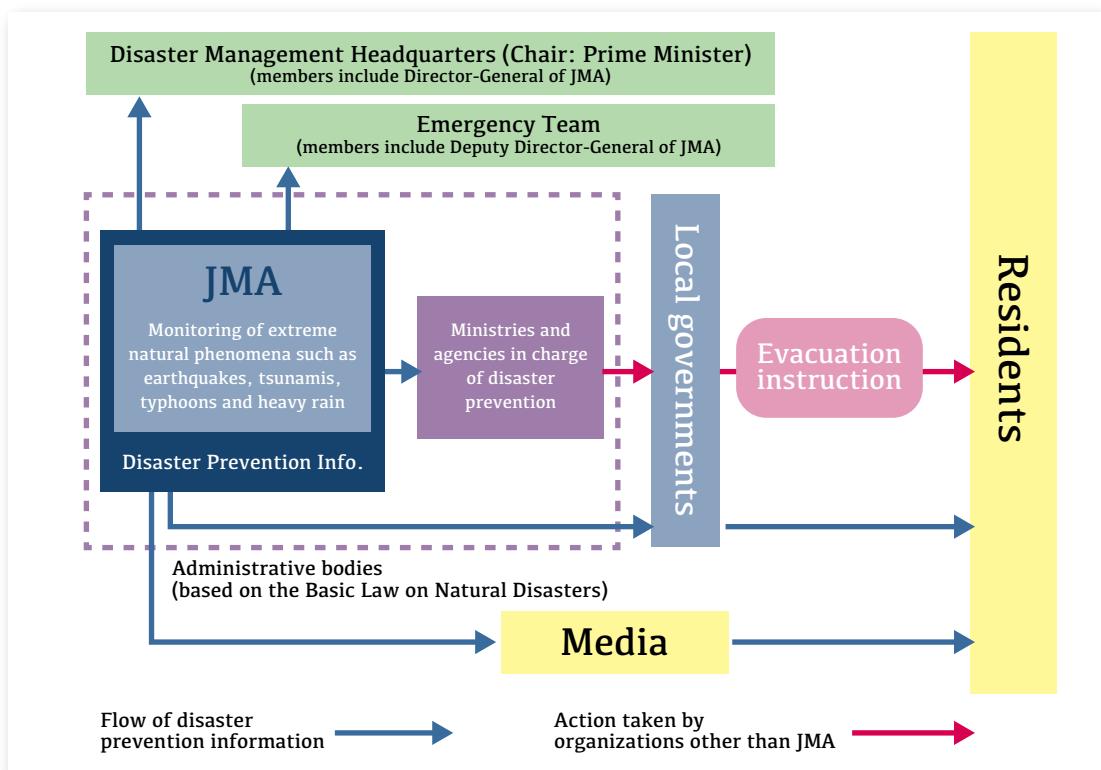
▲ Figure 2: How the news of an upcoming disaster is passed on from JMA to the public
Source: JMA website (<http://www.jma.go.jp/jma/en/Background/mission.html>)

natural phenomenon, informed the media, mostly television (TV), radio and newspaper journalists, about upcoming hazards (Figure 2), who then circulated the news. With the advent of the internet, it is now possible to get the latest updates directly from JMA's website without waiting for the news to be published or broadcasted.

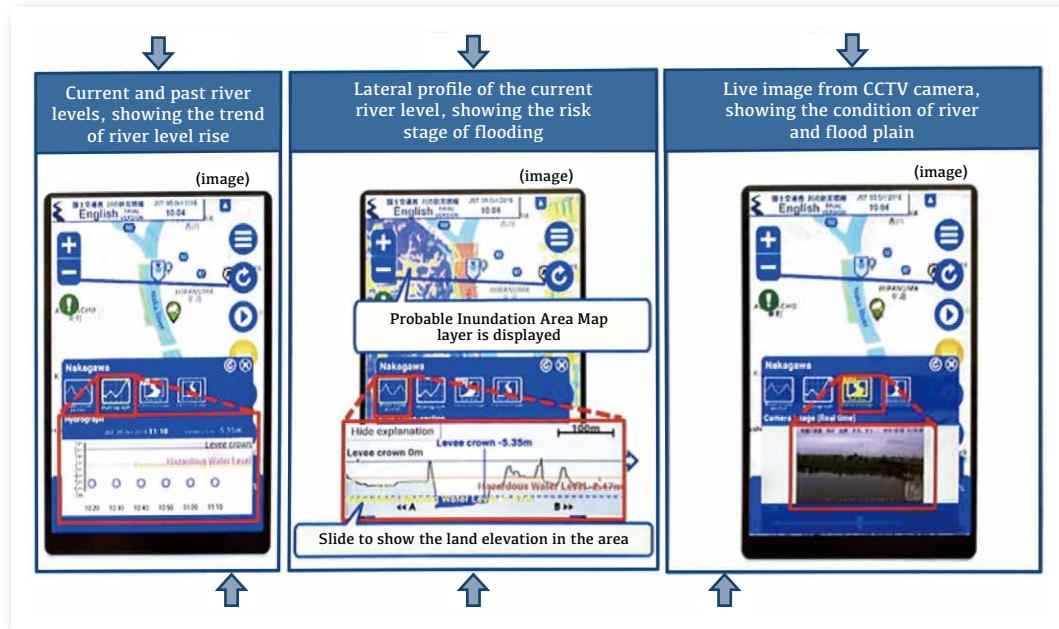
▲ Figure 3: River monitoring system through smart phone app. (Source: MLIT)

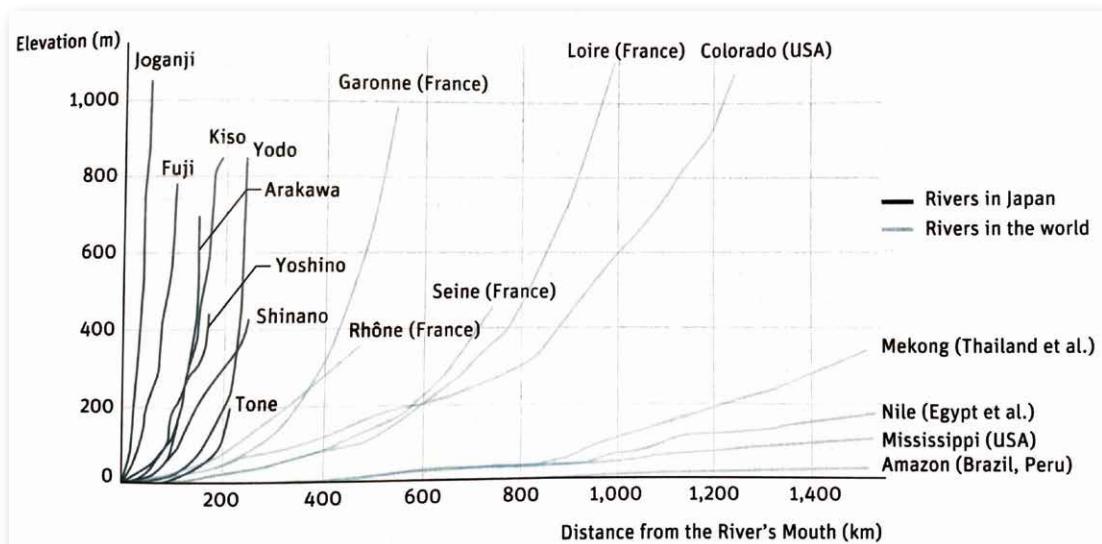
▲ Figure 6: Comparison of elevation and distance of some rivers around the world
(Source: National Institute for Land and Infrastructure Management 2004)

Japan has a large percentage of mountainous terrain within its small land area compared to most other countries of the world. This makes each river's watershed area small and its overall length short. Almost all the rivers run a short distance while the height difference from the upper to lower stream is significant⁶ (Figure 1). These relatively steep rivers have fast water velocity, and this causes sudden change in water levels downstream after heavy rainfall.

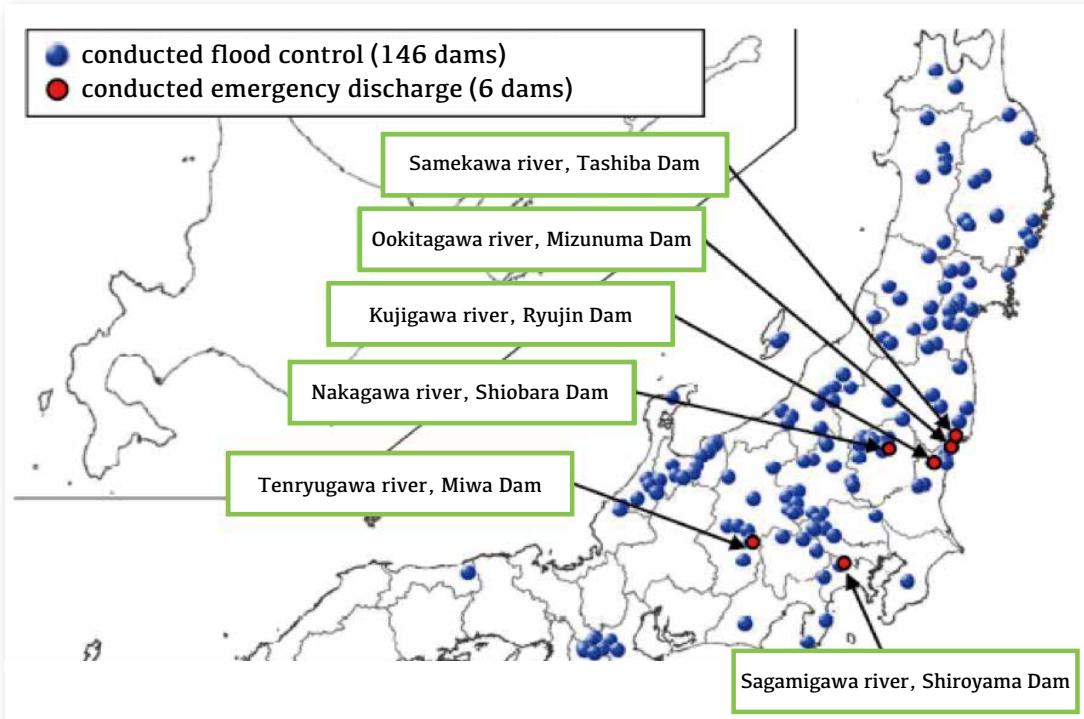
▲Figure 7: Dam operation during Typhoon Hagibis (Source: MLIT)

Since most dams in Japan controlling floods were constructed for multi-purpose use, the entire capacity of dam reservoirs cannot be used to store floodwater. The other users of the facility, such as users of irrigation, water supply, and hydropower generation also share the costs of the construction, and the operation and maintenance of the dams have to accommodate their rights and requirements even in cases of emergency. A multi-purpose dam is undoubtedly a more efficient investment than single-purpose dams, since the flood protection operations only take place in cases of heavy rain, but this gives the other users rights to claim the reservoir water even during emergencies.

During typhoon Hagibis, users at 33 dams agreed to the advance discharge of water without any compensation. Stored water was discharged beforehand, and additional capacities were secured by lowering the water levels of the reservoirs. The government is examining measures where the other users would allow discharging some water from the dam reservoir, which includes their share, to secure enough capacity during emergency in exchange of a compensation.

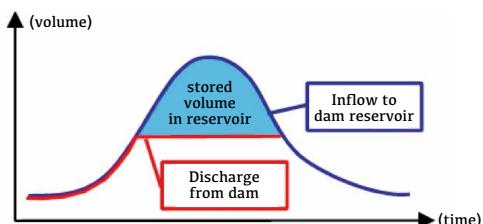
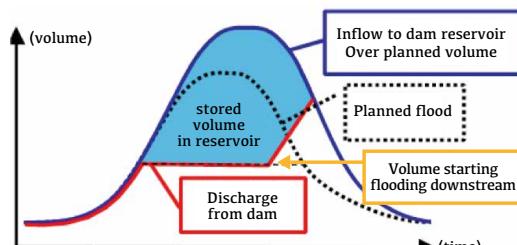
Planned operation

Emergency discharge operation for flood over planed volume

▲ Figure 8: Planned dam operation and emergency discharge operation
(Source: MLIT)

When flood volume flowing into a dam reservoir is expected to exceed the limit and reach the maximum water level, operators gradually increase discharge volume to the amount equal to the inflow (Figure 8). This operation is required not to destroy a dam body by the overflowing floodwater. Flood volumes downstream rapidly increase following emergency discharge operation, and this may cause flooding near the downstream area. The flood protection facilities of embankments, weirs, etc. are constructed to carry planned flood volumes. Since the discharge volume is equal to or smaller than the inflow volume, this operation does not worsen flooding situation in downstream. In the event of floods that exceed the reservoir capacity, dams can reduce water levels downstream before transitioning to emergency discharge operation.

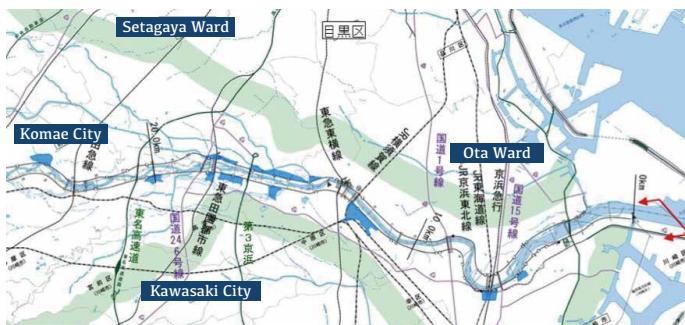
▲ Figure 9: Tamagawa river basin (Green) and inundated areas (Blue)
(Source: MLIT)

During typhoon Hagibis, inland urban flooding occurred in many areas along the Tama river. The affected areas include the high-end residential areas such as Denenchofu of Ota ward in Tokyo and Musashikosugi in Kawasaki City. About 2000 houses were inundated and some 1000 houses were damaged (Table 1). In Musashikosugi residents of a prestigious high-rise apartment could not use basic facilities such as electricity, water, sewerage, and elevator for a week since the electric facilities underground were inundated. Floodwater from the river inundated 40 houses over an area of 70 ha near the Futakotamagawa station in Setagaya ward of Tokyo, where the government has not been able to construct embankments because of disagreement from the local communities.

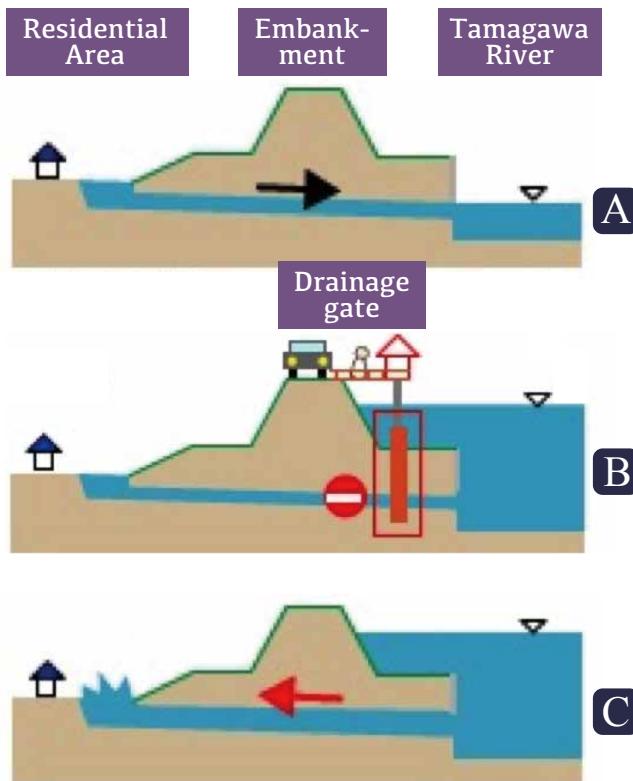
▲ Figure 10: gate operation (Source: Modified from MLIT)

A	Normal time
	Water is discharging into the Tama river through drainage systems.
B	Operation at Flooding
	The gate is closed to protect residential area from floodwater flowing to the residential areas.
C	This time
	The gate was not closed, and floodwater inundated the residential areas.

Incorrect operation of the drainage systems also made the damage larger (Figure 10). When the water level reached a critical level, the Ota Ward office closed a drainage gate that connects Denenchofu to the Tama river, to protect the residential area from inflowing floodwater. However, the Setagaya Ward Office could not close the other gate, and the water soon flowed in, flooding many areas of Setagaya Ward and the low-lying areas of Denenchofu. Similarly, in Kawasaki city, the government could not close five gates, and the water from the Tama River flowed in flooding the residential areas. Kawasaki and Setagaya governments explained that the gate operators could not access these gates because of inundation and traffic jams.
